UNITED STATES COAST GUARD, FIRST DISTRICT
LIGHTHOUSE PROTECTION STUDIES, NEW ENGLAND

HIGHLAND LIGHT STATION
NORTH TRURO, MASSACHUSETTS

JULY 1988

HIGHLAND LIGHT STATION, NORTH TRURO, MA
EROSION STUDY

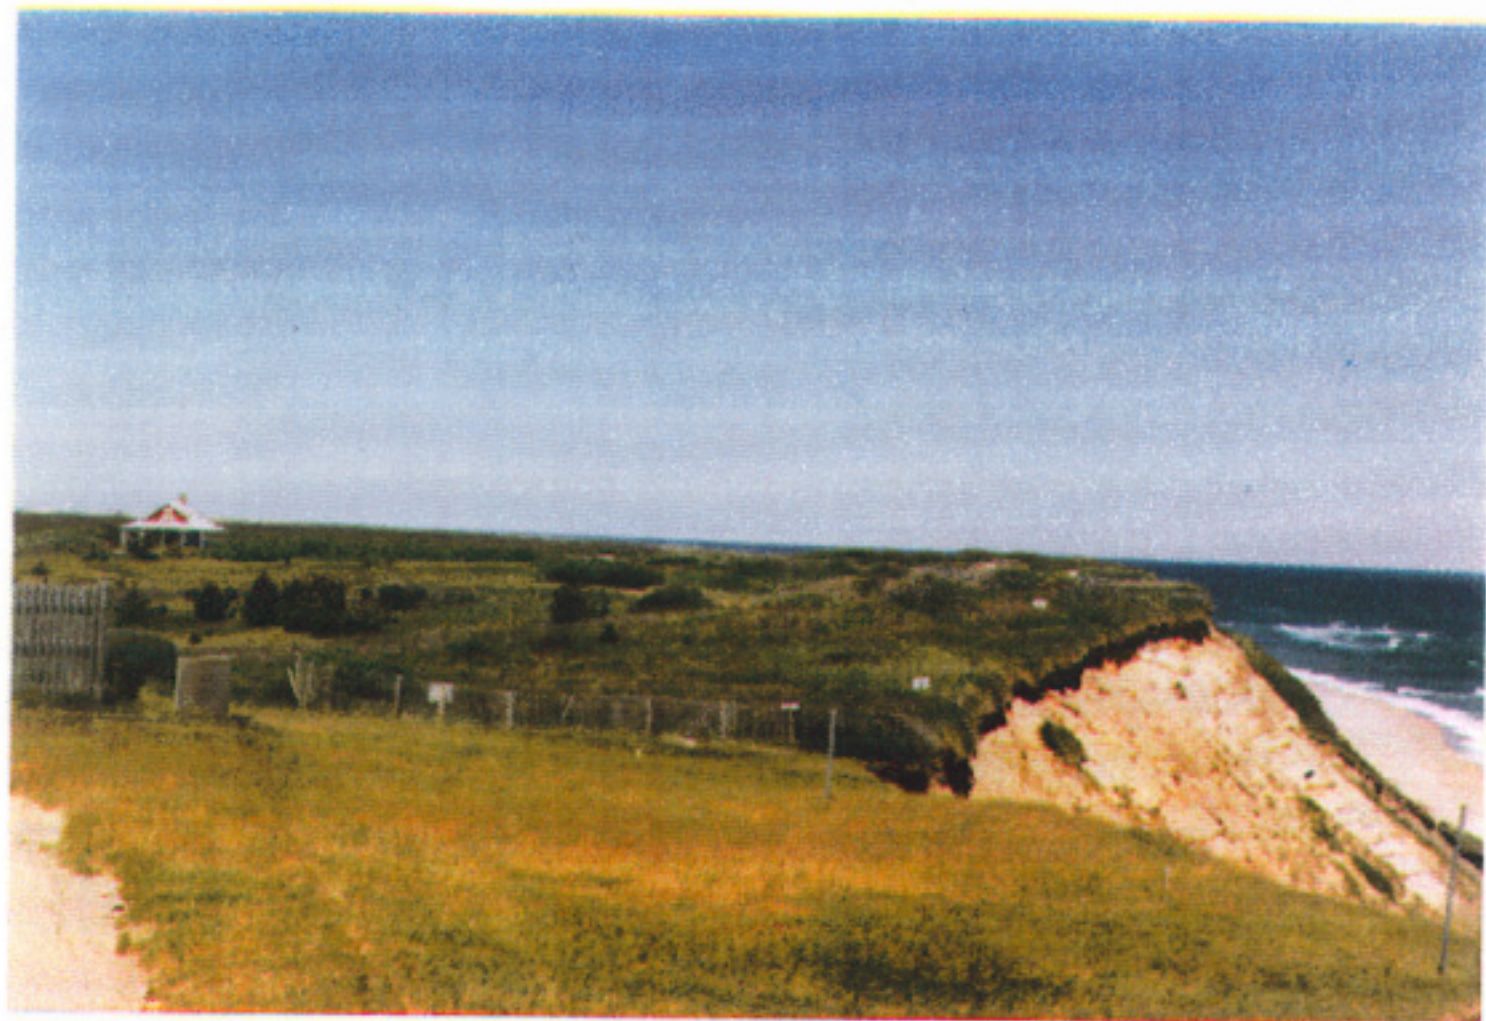
The area immediately adjacent to Highland Light incorporates characteristics of both Upland Forest and succession areas. No attempt was made to accurately define the precise types of vegetation growing there. Figure 3 shows that the area is well covered with low scrub type material on the upland areas. The cliffs are vegetated in part and generally erosion is least where this vegetation occurs (see Figure 4). Due to the well established mat of vegetative growth on the uplands bordering the bluff, little erosion is caused by wind deflation. Successful efforts by the National Park Service have kept pedestrian and vehicular traffic to a minimum in vicinity of the Light and thus the vegetation has continued to flourish and provide its protective cover.

FIGURE 3 - PHOTO SHOWING LOW SCRUB MATERIAL ON UPLAND AREAS

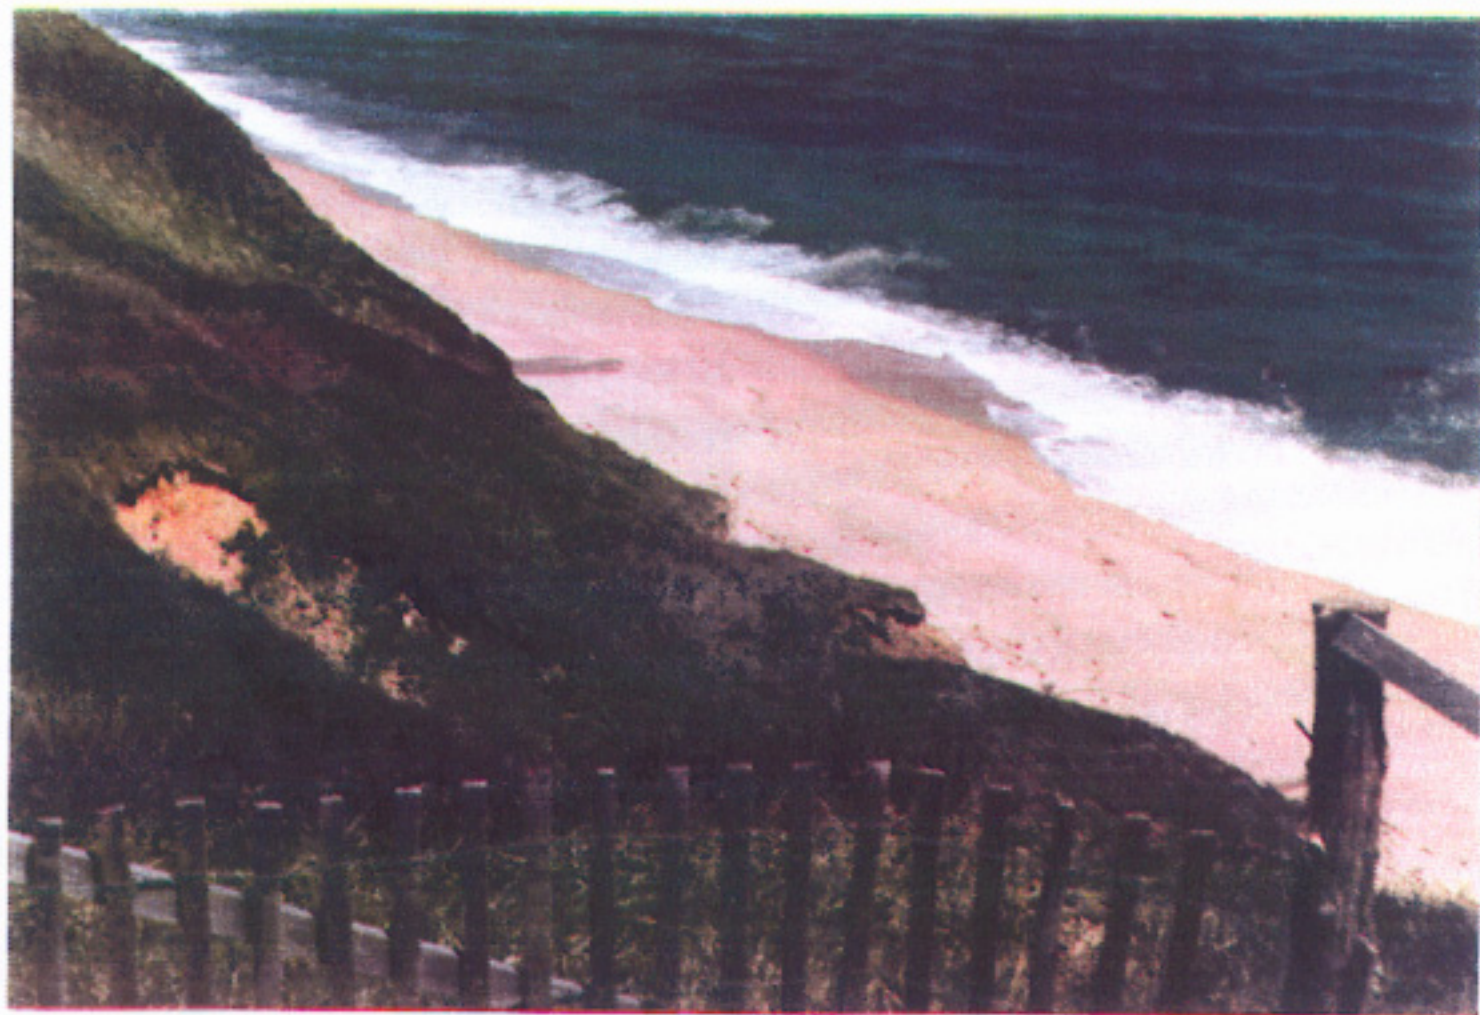
FIGURE 4 - PHOTO SHOWING VEGETATION ON CLIFFS

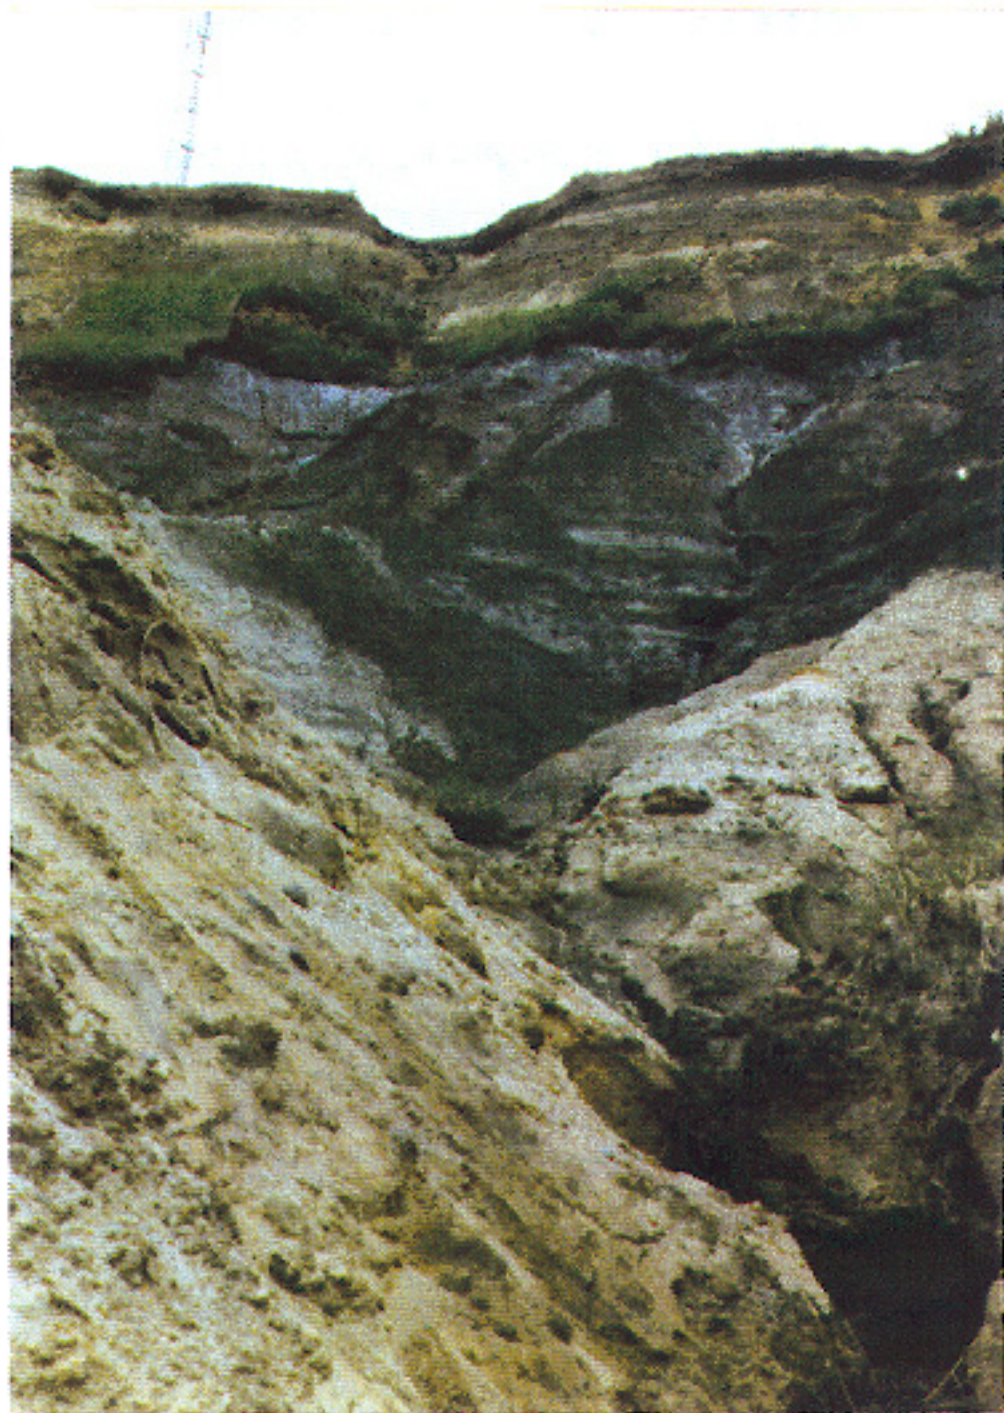
As can be seen in Figure 2, the clay in the cliff is of variable thickness and distribution but is certainly an abundant and common sedimentary layer. As precipitation falls on the upland area it will infiltrate the eolian (wind blown) layer and soils present and percolate through the sandy layers until clay is encountered. The clay layer presents an impermeable barrier to the infiltrating water causing it to move parallel to the clay layer rather than through it. This generally horizontal movement will commonly cause water to move to the cliff face and drain and seep down the cliff face from the point of exit. Figure 5 well illustrates this phenomenon.

FIGURE 5 - PHOTO SHOWING CLAY LAYER IN CLIFF

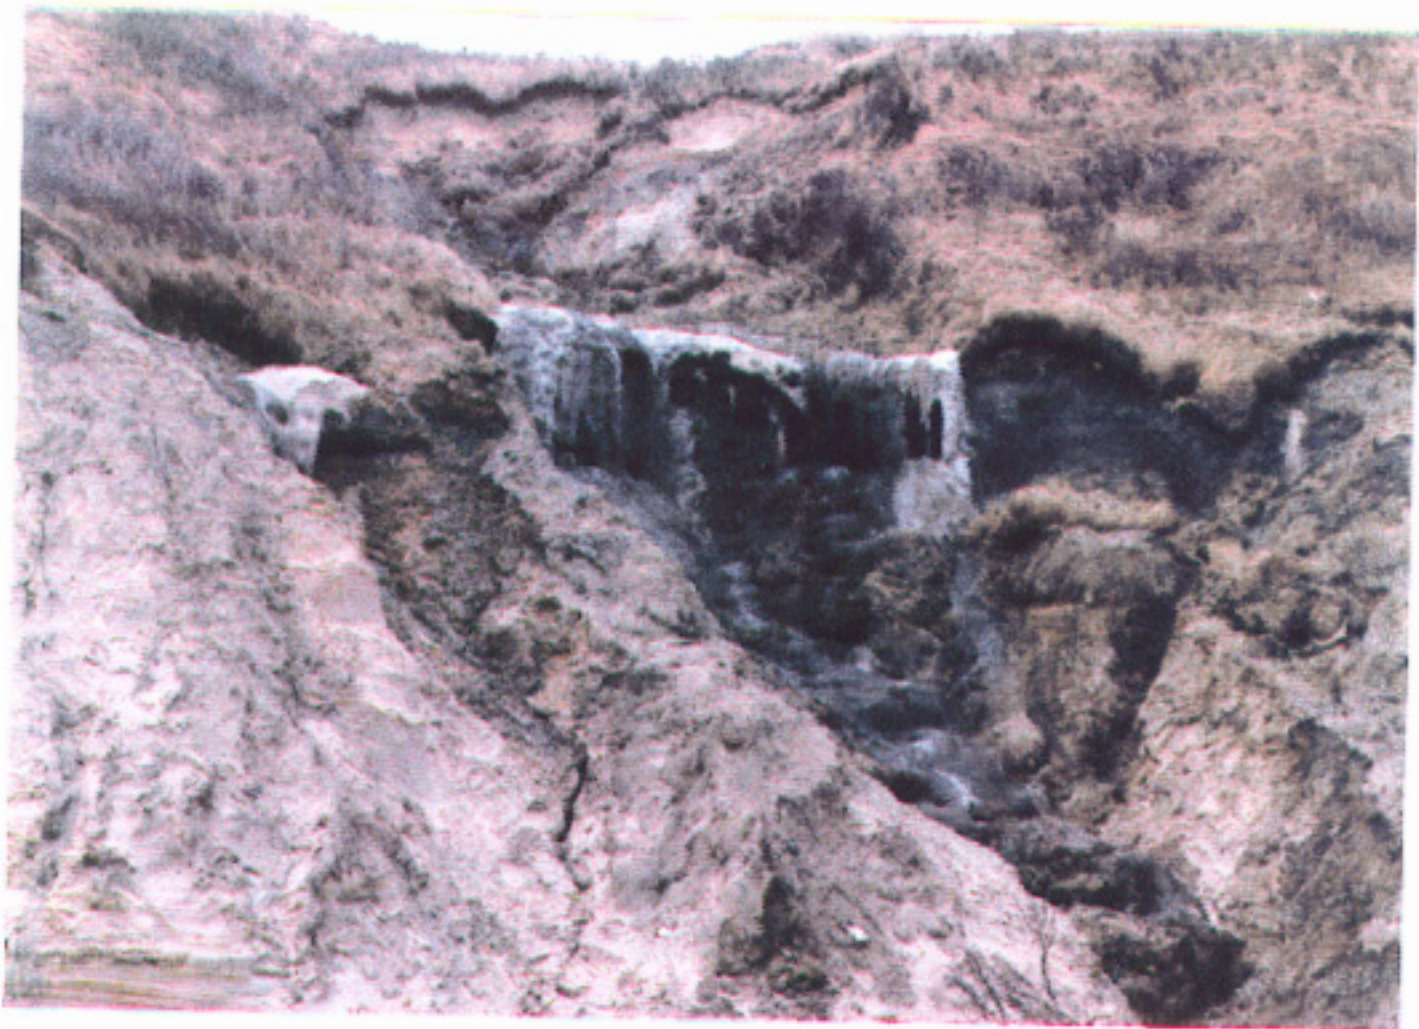
PHOTO 1 - RUNOFF (ICE HERE) FLOWING DOWN CLIFF

Photo 1 shows the runoff as it runs down the cliff, in this photo, the runoff is seen as ice since the picture was taken on a cold day in January.

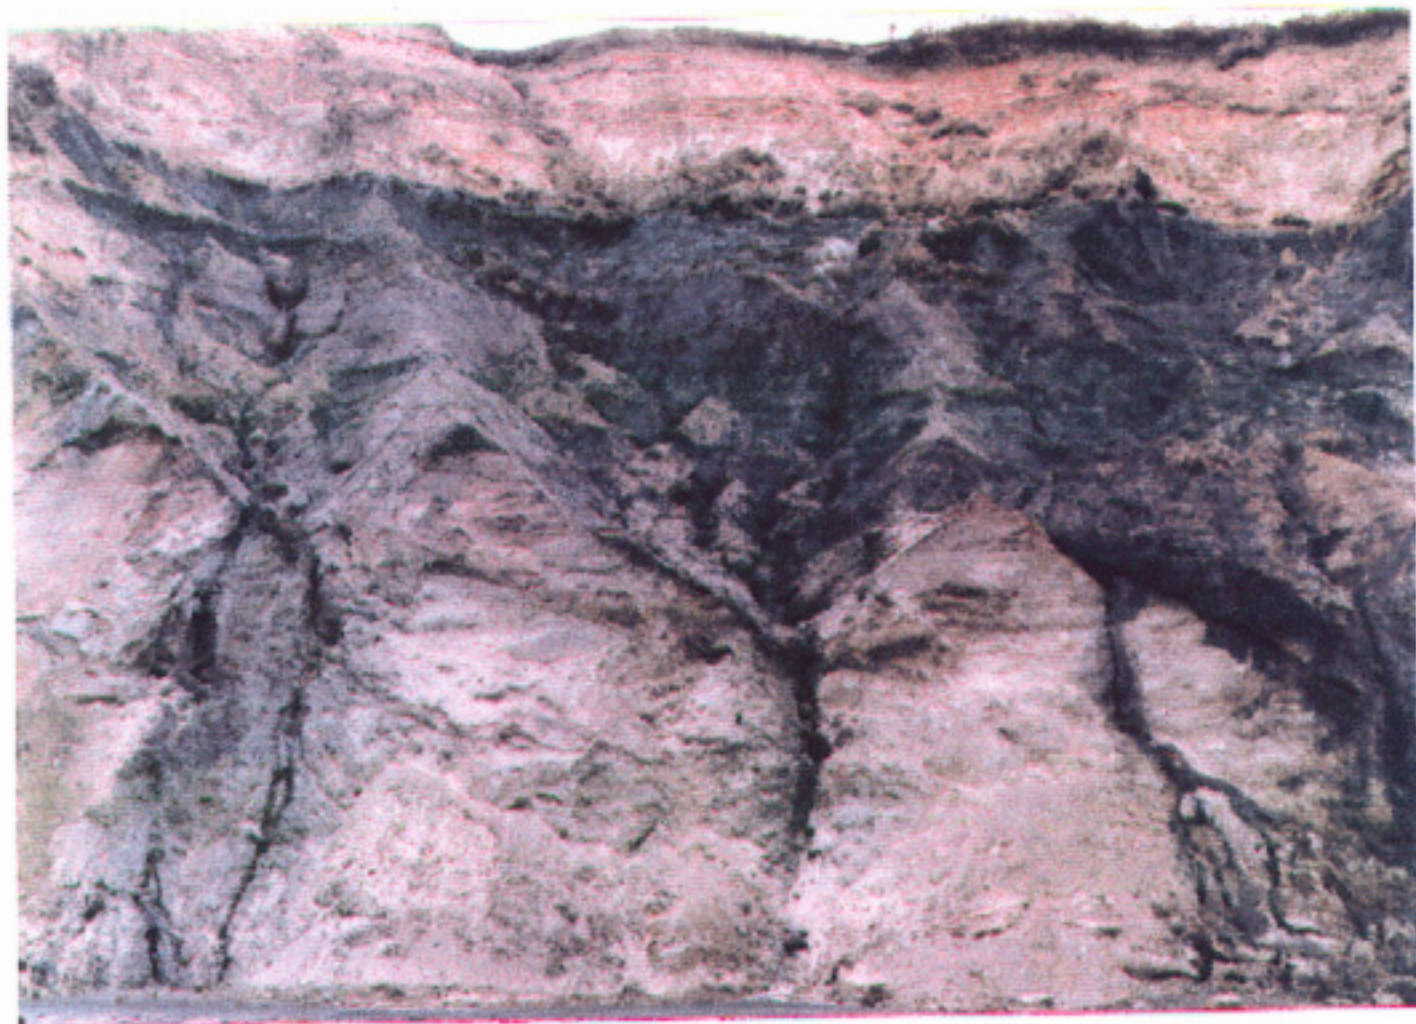
PHOTO 2 - GULLIES FORMED BY THE RUNOFF

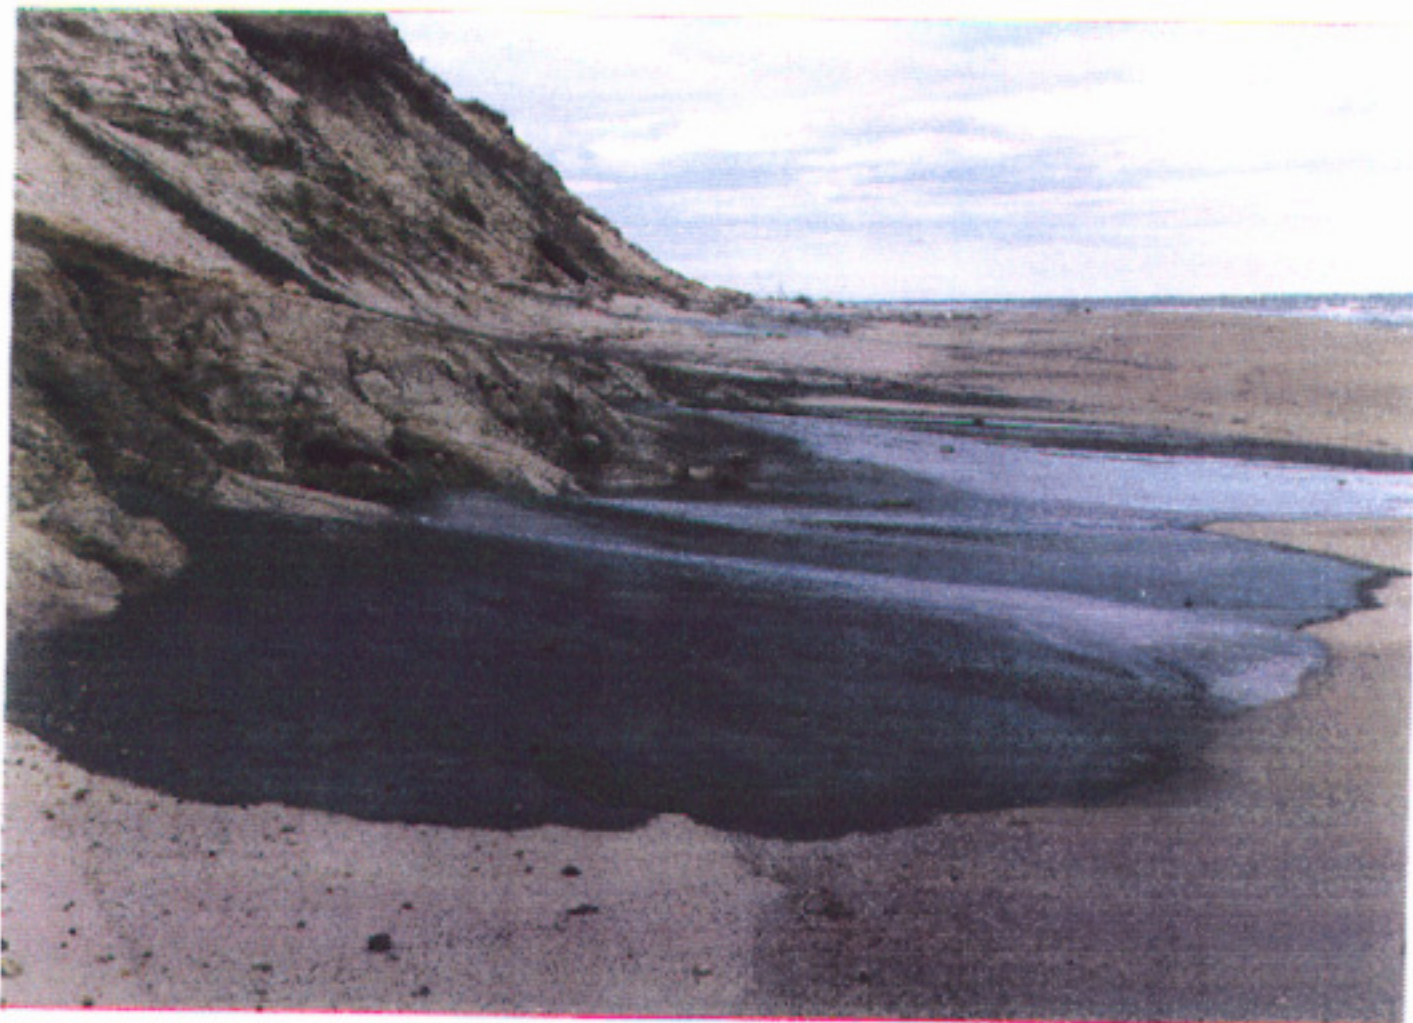
PHOTO 3 - CLAY MATERIAL ERODED FROM CLIFFS DEPOSITED ON BEACH

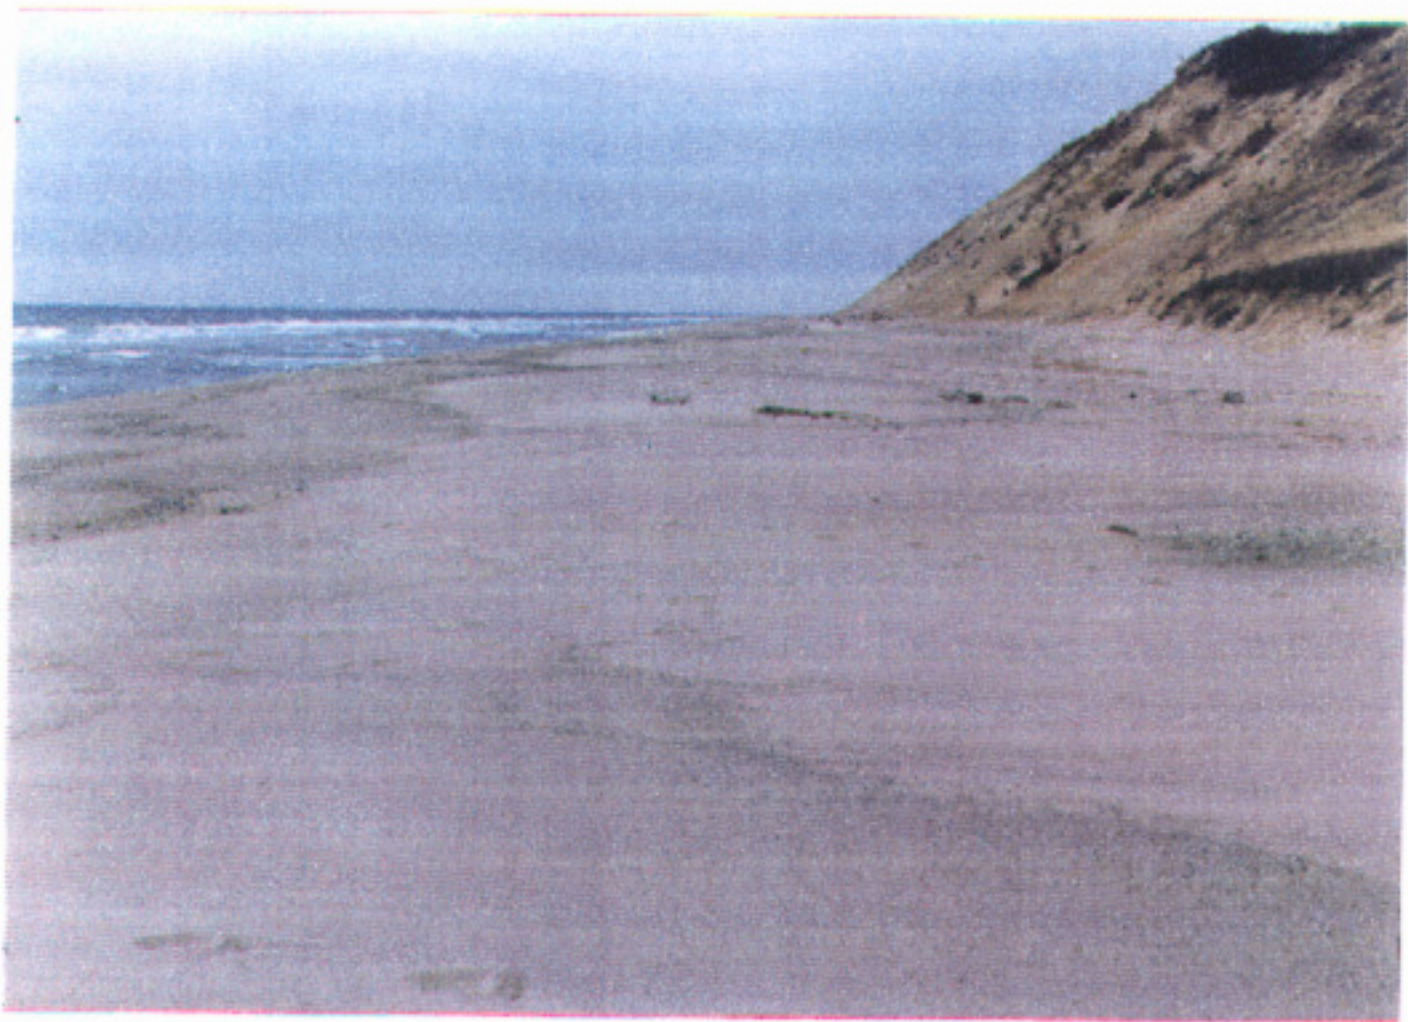
PHOTO 4 - WIDE BERM PROTECTS CLIFF 1/4 MILE SOUTH OF LIGHTHOUSE

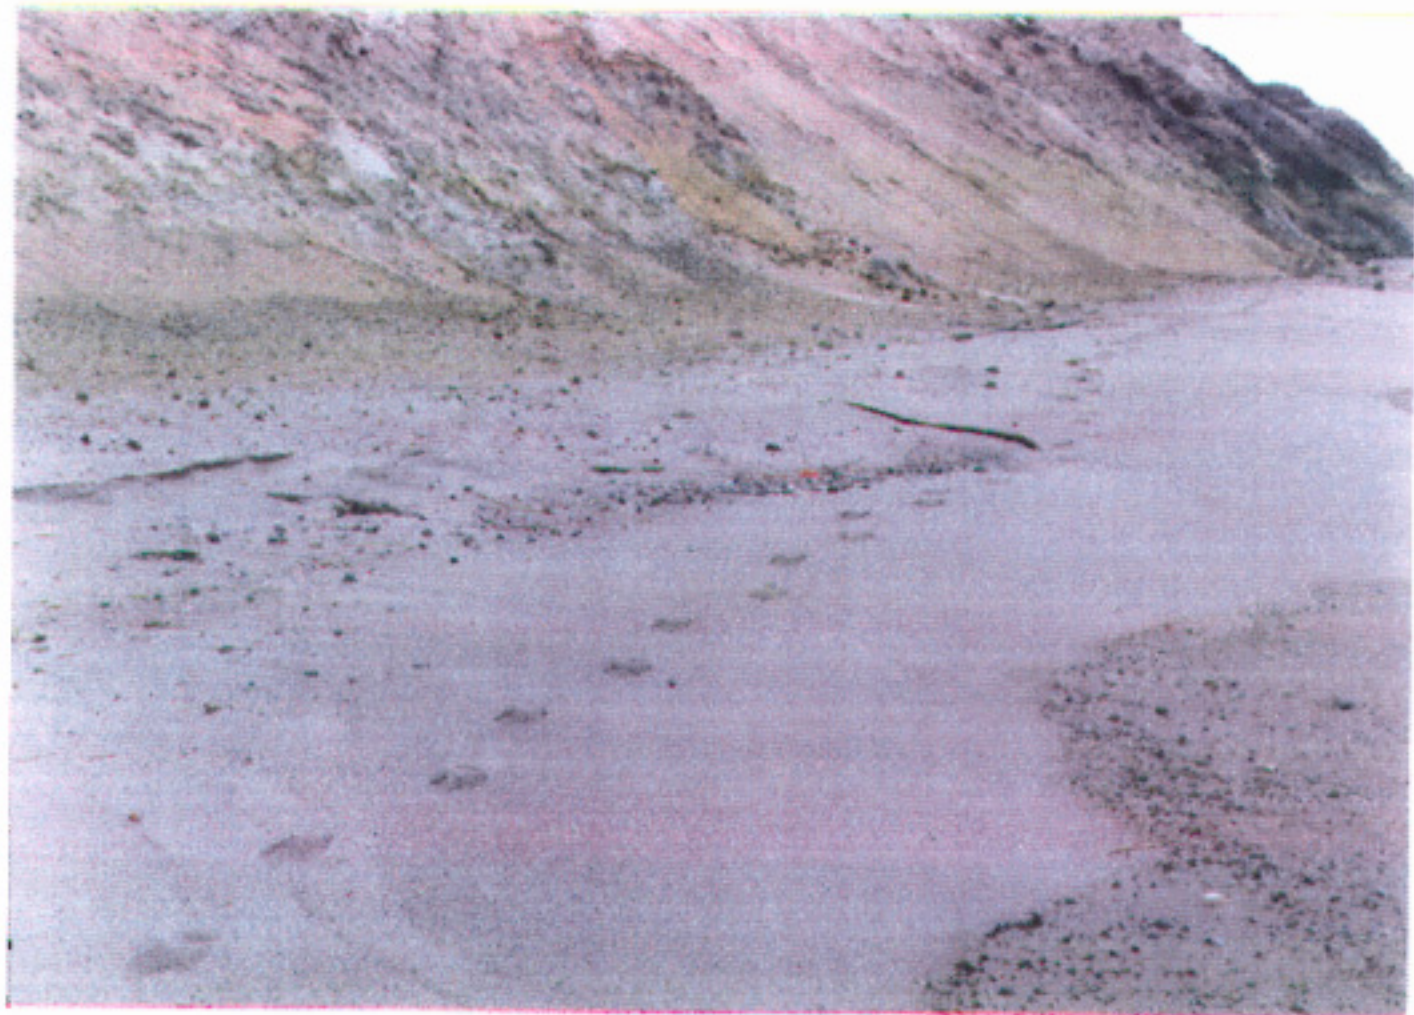
PHOTO 5 - NARROW BERM 200 YARDS SOUTH OF LIGHTHOUSE

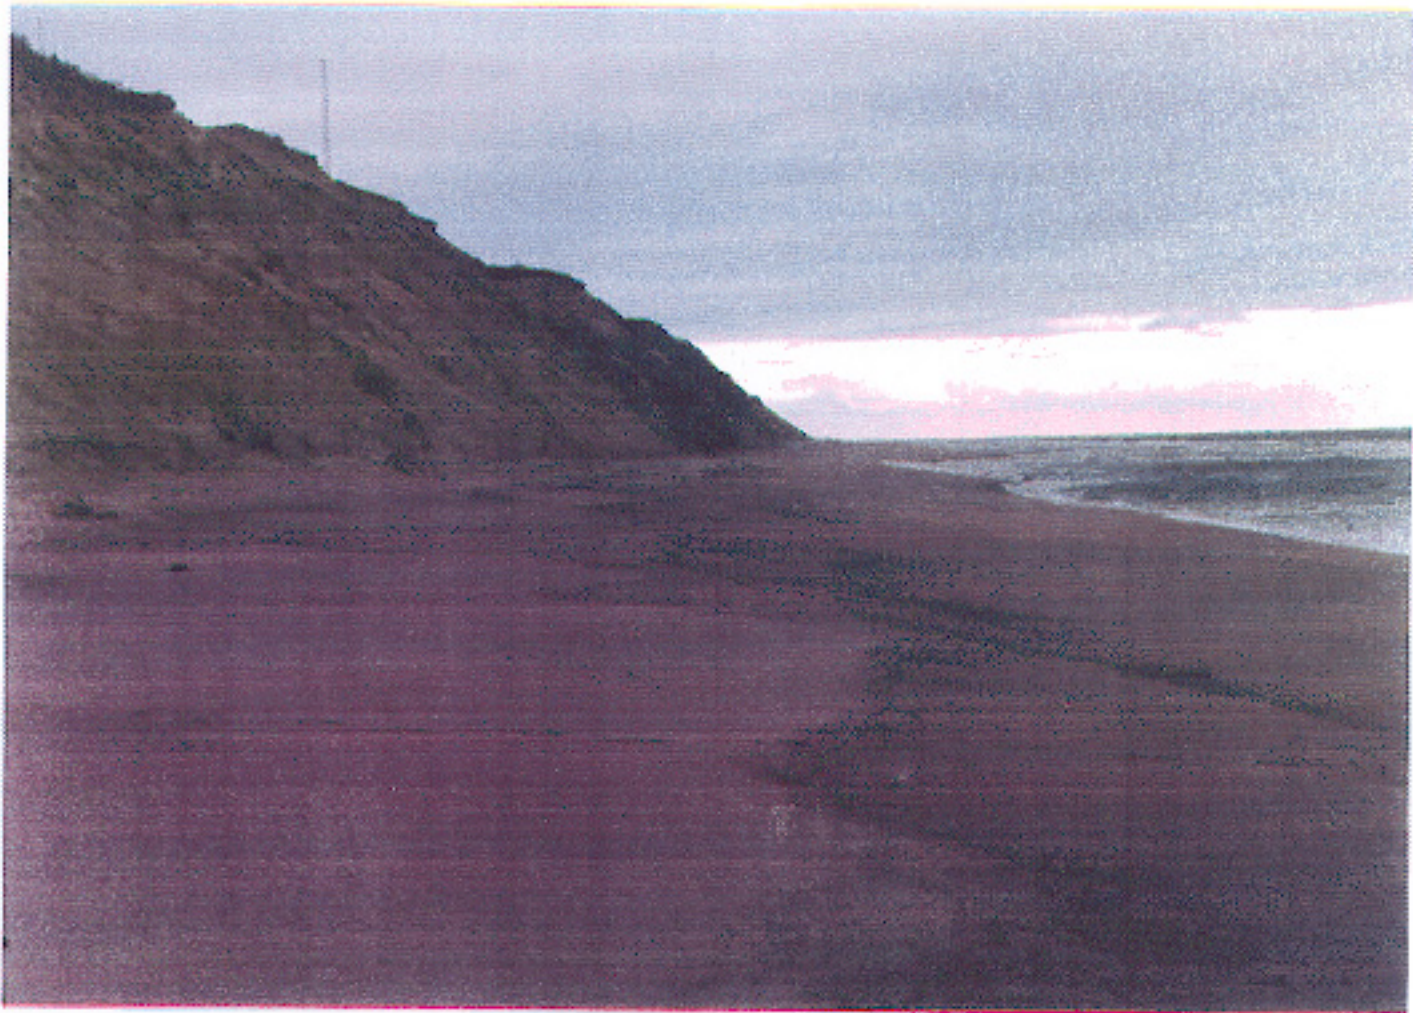
PHOTO 6 - INDENTATION IN SHORE AT HIGHLAND LIGHTHOUSE

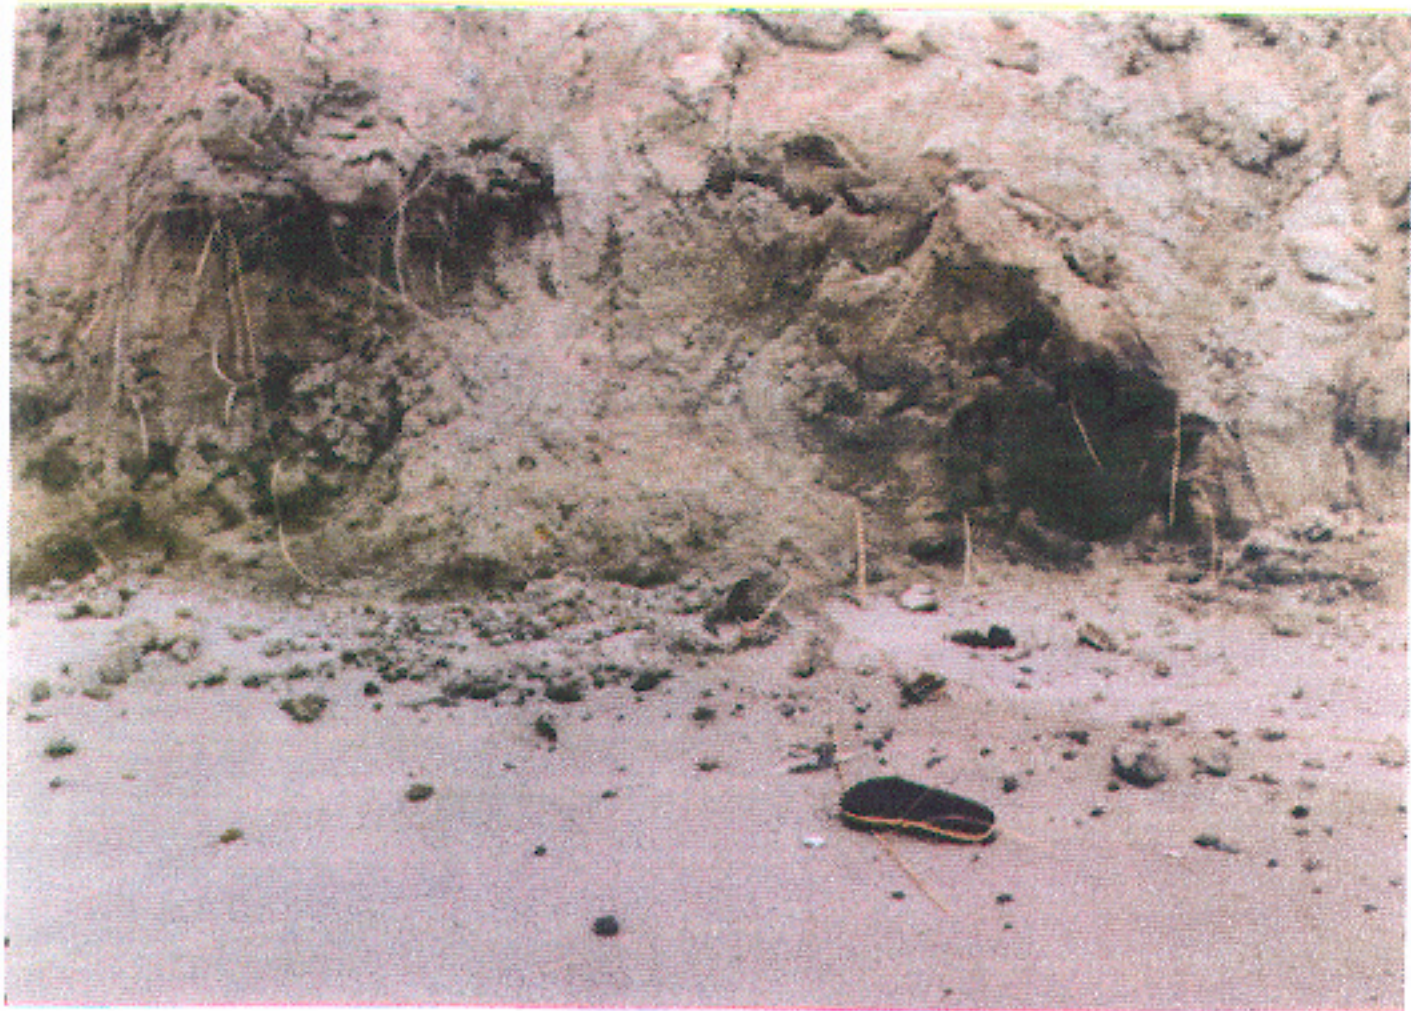
PHOTO 7 - BORES FORMED BY BREAKING WAVES

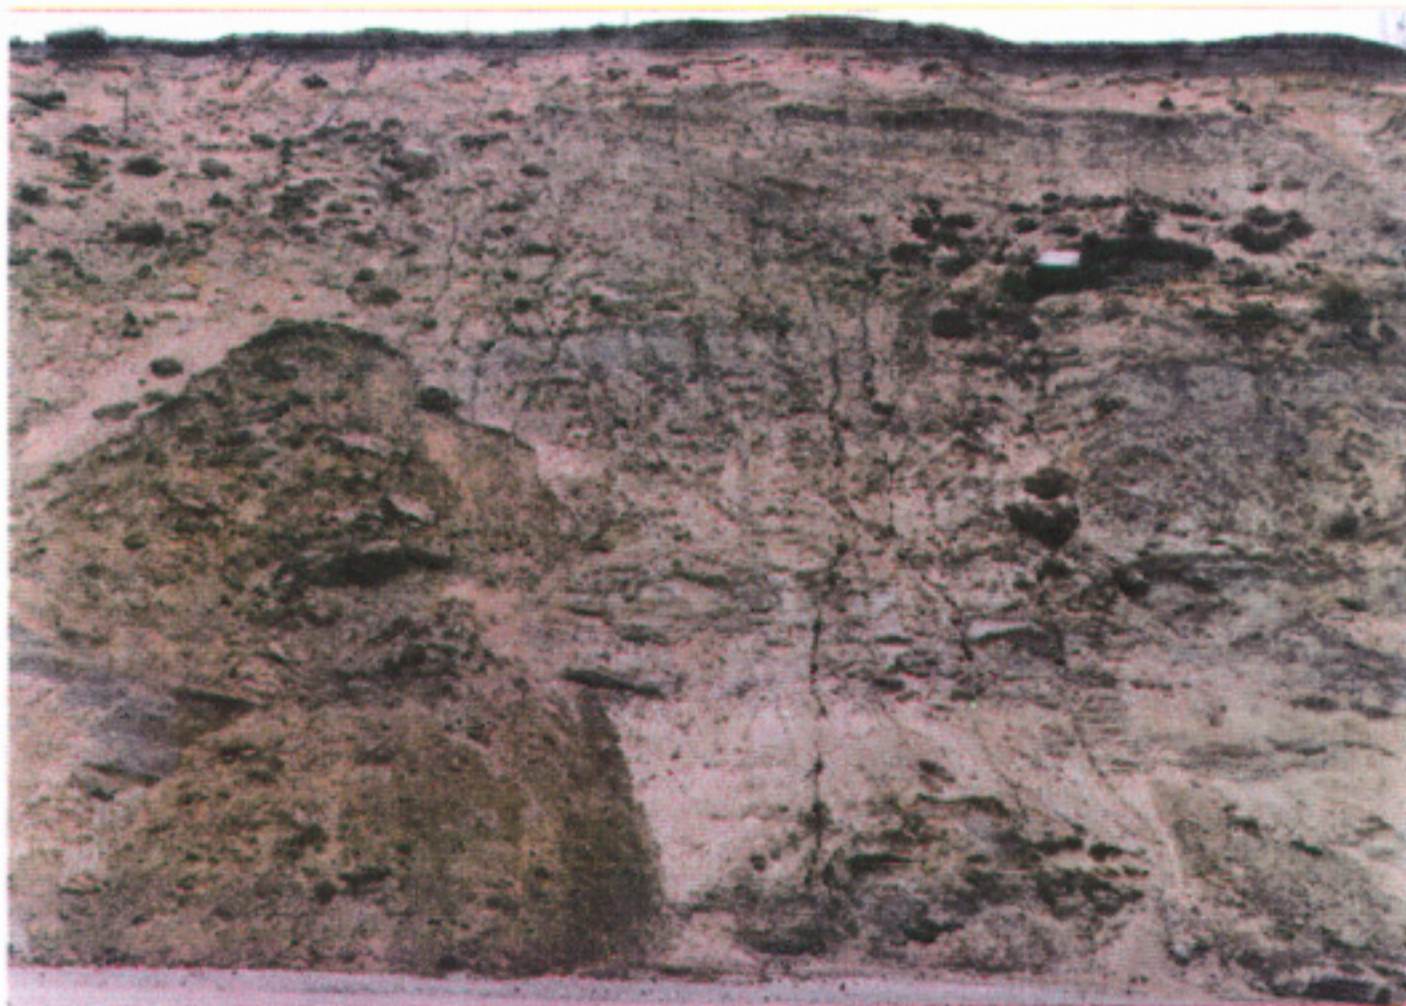
When the cliff becomes too steep, it eventually fails in the form of a landslide as shown in Photo 8. This picture was taken at the cliff base directly in front of the lighthouse. The base of the transmitting tower is in the extreme upper right hand corner of the picture. The white chunk of concrete on the upper right hand part of the cliff is the remains of the oil houses which fell over the cliff.

PHOTO 8 - LANDSLIDE CAUSED BY ERODING CLIFF

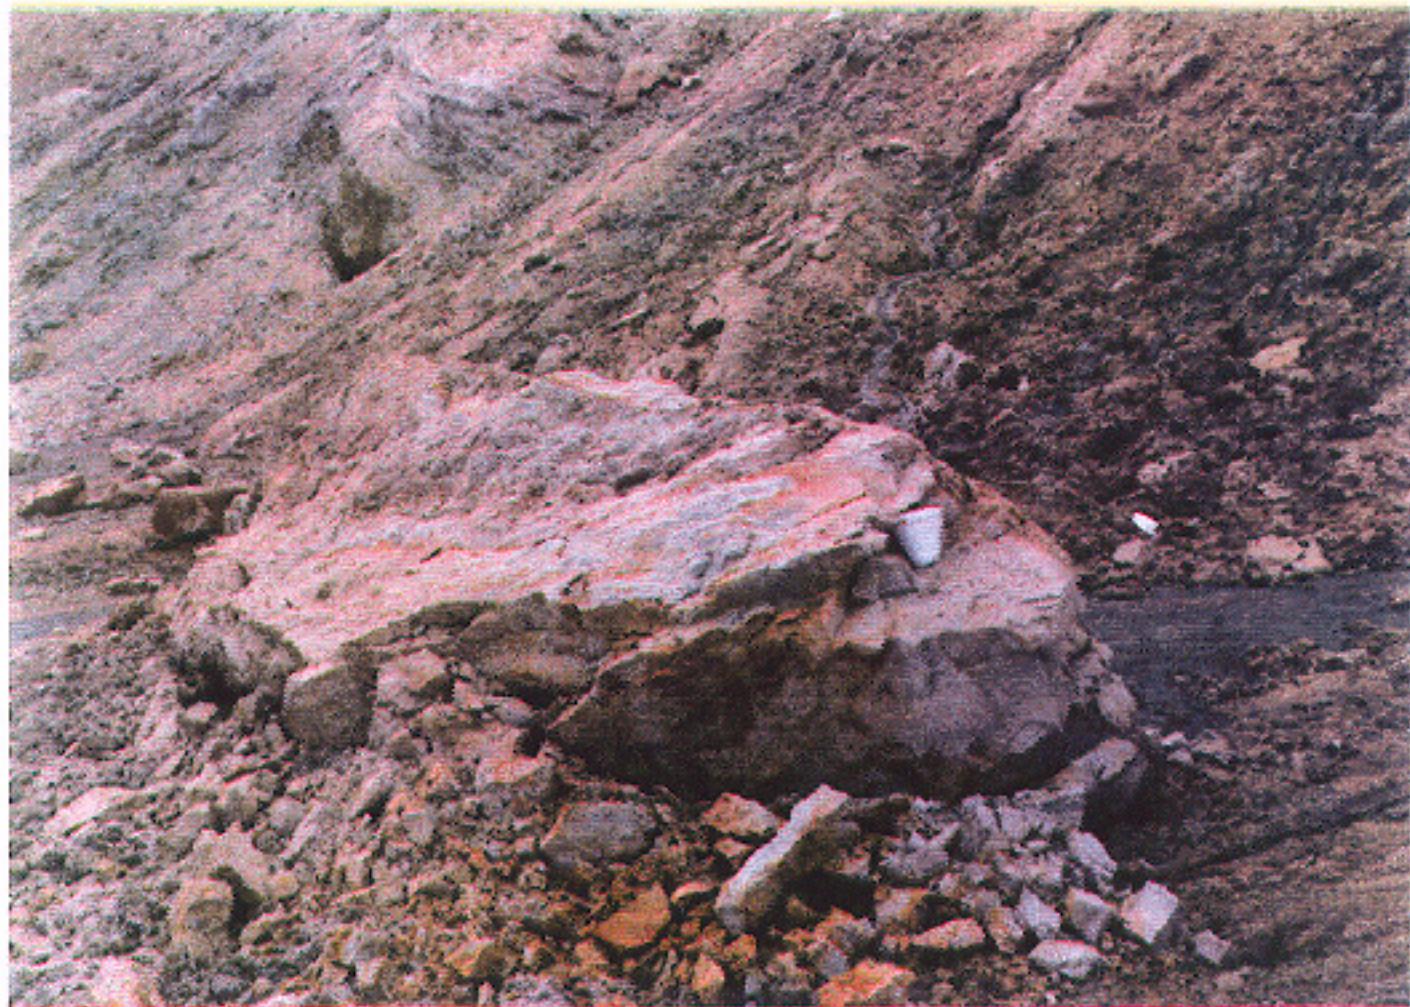
The clay portion of the cliff, being cohesive, does not fail as landslides. It usually falls off as in chunks. The chunk in Photo 9 fell a few hundred yards north of the lighthouse.

PHOTO 9 - CLAY AREA OF CLIFF WHICH FELL OFF AS CHUNK

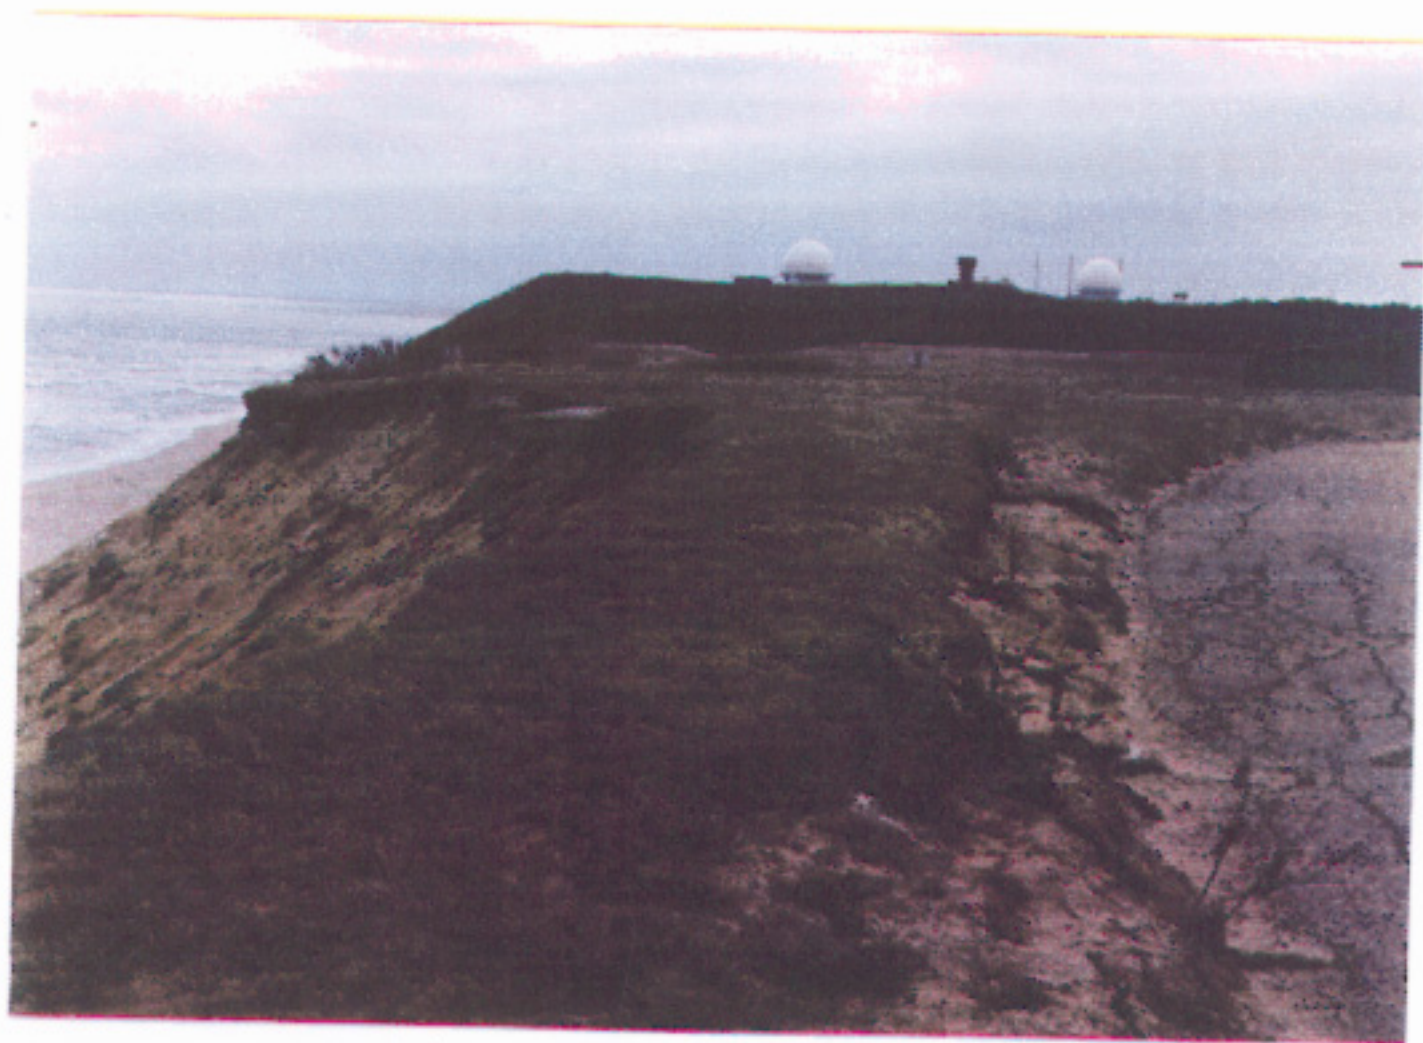
Photo 10 shows the effects of the erosion. The concrete slabs are the remains of the oil houses which fell over the bluff. The road too, will soon be lost due to the erosion.

PHOTO 10- EFFECTS OF THE EROSION
